Minerals Inspection Report

Mine Name: Diamond Mountain Resources	Permit Number: M/47/0066	Mine Status: Active
Operator Name: Deseret Generation and Transmission	Inspection Date: 6/16/2015	Permit Fees: Paid
Inspector(s): A. Abate	Inspection Time: 2:00 PM	Bond Amount: \$275,000
Attendee(s): B. Dickson, D. Herron	Weather: Thunder storms	Bond Escalation: 03/17/2015
Inspection Purpose: Routine inspection		Prior Inspection: 10/14/2014

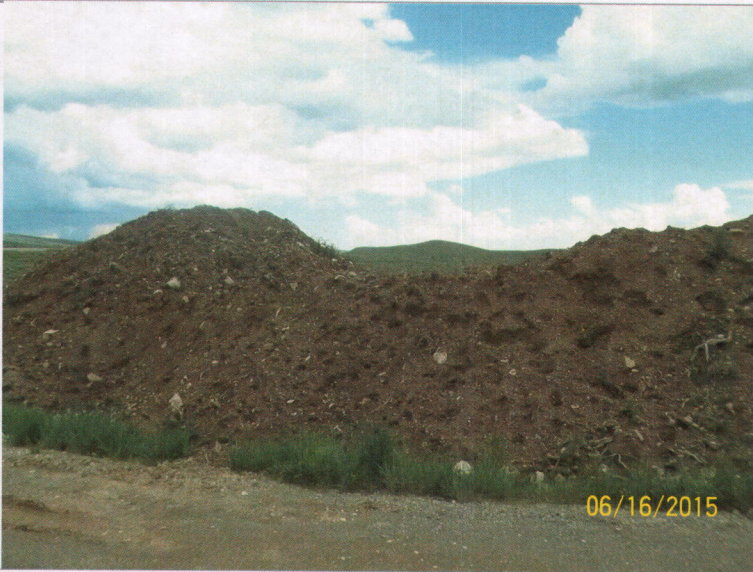
8. <i>Soils</i>	<input checked="" type="checkbox"/>	<input type="checkbox"/>
No issues identified		
9. <i>Revegetation</i>	<input checked="" type="checkbox"/>	<input type="checkbox"/>
Topsoil pile needed some additional vegetation; only parts of it were vegetated. Mr. Dickson indicated that it was seeded in the fall but seed did not take very well.

Topsoil pile was partially vegetated.

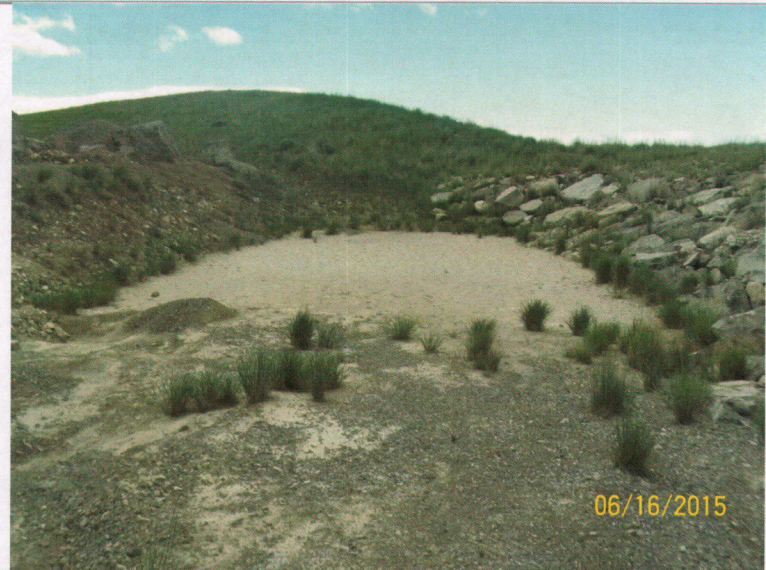
Sediment Pond 1 located at the southwest corner of the mine was dry.

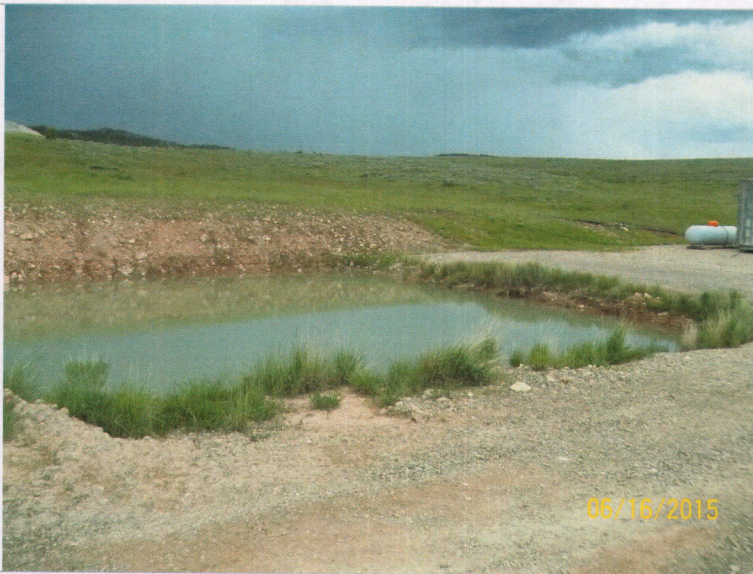
3. <i>Protection of Drainages/Erosion Control</i>	<input checked="" type="checkbox"/>	<input type="checkbox"/>
No erosion problems were identified along the road and near the sediment ponds. Sediment pond 2 located to the southeast of the mine appeared to be at capacity. There was some discussion about possibly enlarging this pond or alternatively, creating a diversion ditch to the first sediment pond to direct stormwater flow there.

Sediment pond 2 located southeast of the mine appeared to be at capacity.

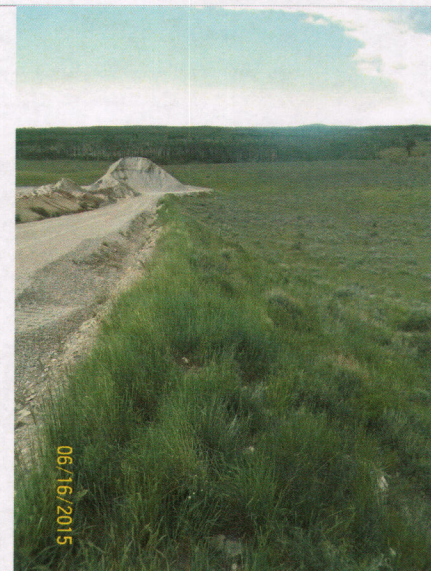
The outslopes of the berms around the perimeter of the disturbance areas were nicely vegetated and function well in terms of controlling erosion.
